**HISTORIC BUILDING ASSESSMENT:
'PLAS SMART'
FR BOSTON LODGE WORKS
MINFFORDD
GWYNEDD**

*on behalf of Ffestiniog Railway Heritage Ltd
and the Festiniog Railway Company*

December 2011

ASC: 1388/FRC/1r

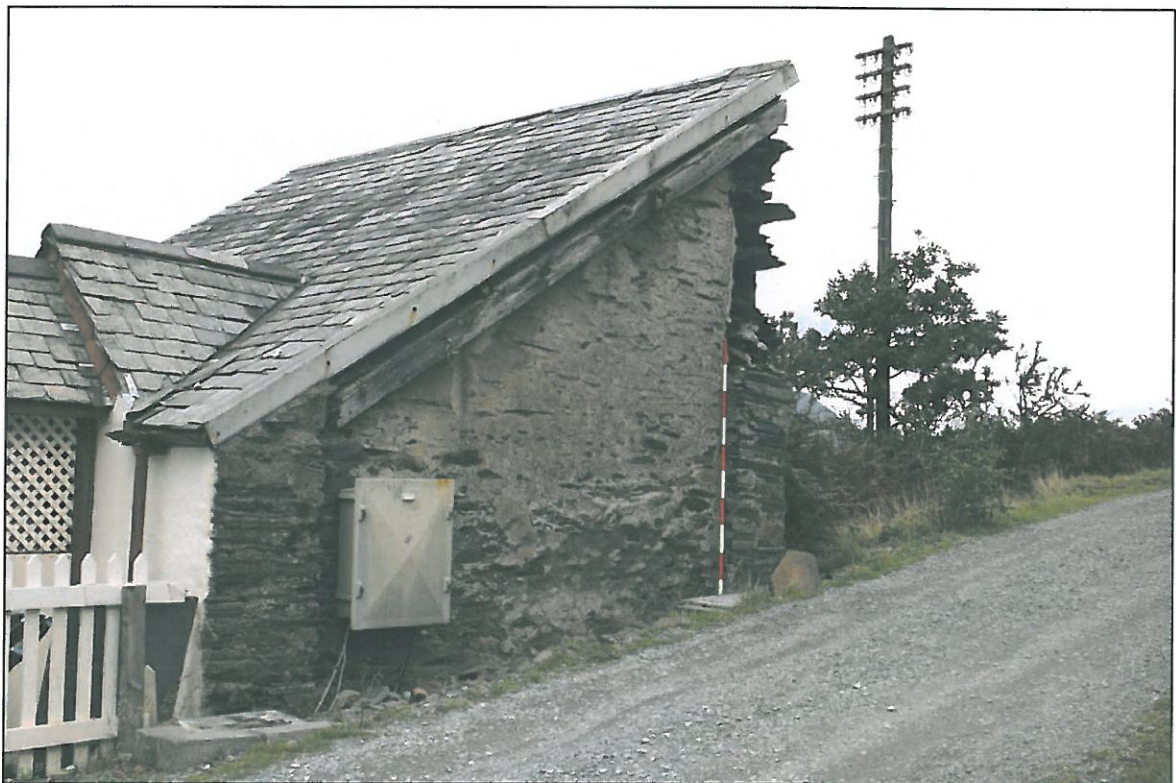
Figure 12: South-east elevation.
The jamb of the former archway is visible beside the ranging rod

- Felting and re-slating the roof
 - Dismantling and reconstruction of the east corner of the building, to eliminate the present jagged edge and structural weakness

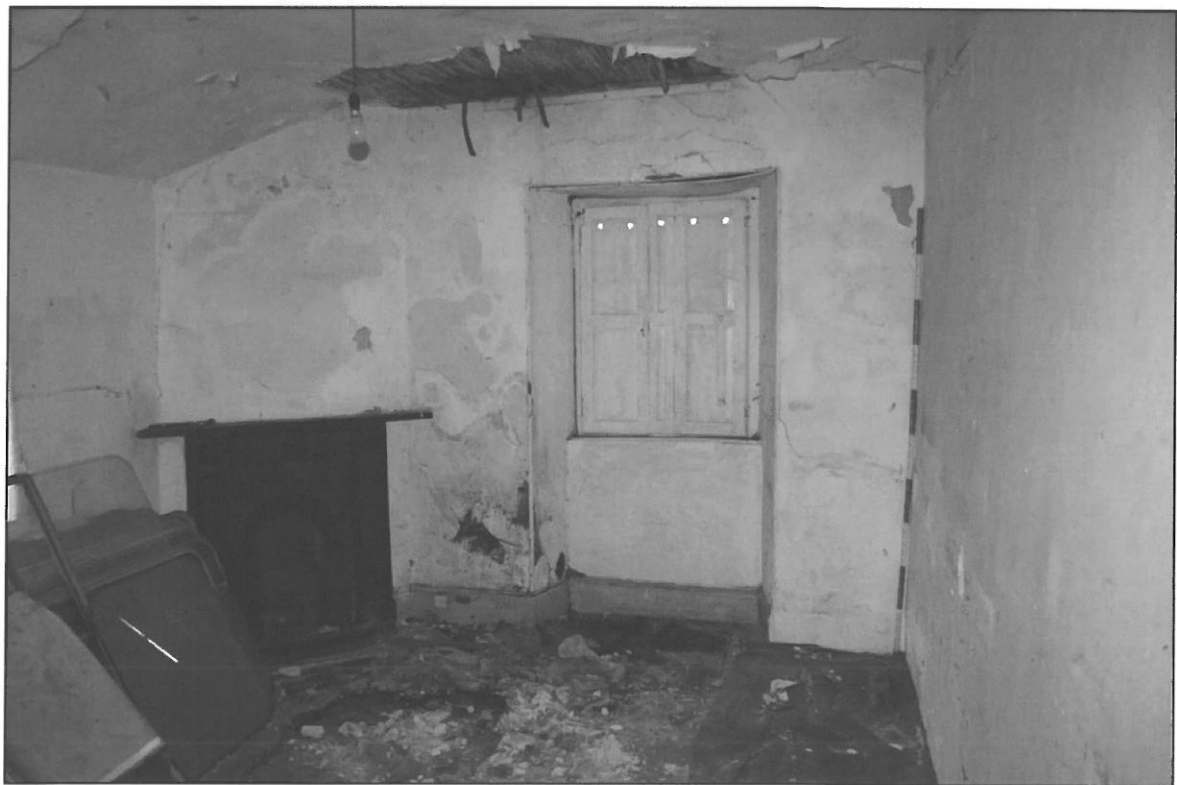
On the north-west side of the screen is the inner room or office (Figs 16, 17), $3.42 \times 3.18\text{m}$ (11'1½" \times 10'4¾"). This is distinguished from the lobby area by having a suspended timber floor, with NE-SW joists and NW-SE floorboards. In the angle of the west corner is a fireplace with a typical 19th-century cast-iron surround and integral mantel shelf, above a slate hearth slab (Fig. 18). In the south-west wall is the 4-light casement window, almost certainly a modern replacement, set in a splayed opening with a deep sill. In the north-west wall a second splayed opening contains the 8/8 sash window with folding 3-leaf panelled shutters, almost certainly original. Some plain skirting boards remain on the north-west wall.

Figure 16: Office, looking north-west

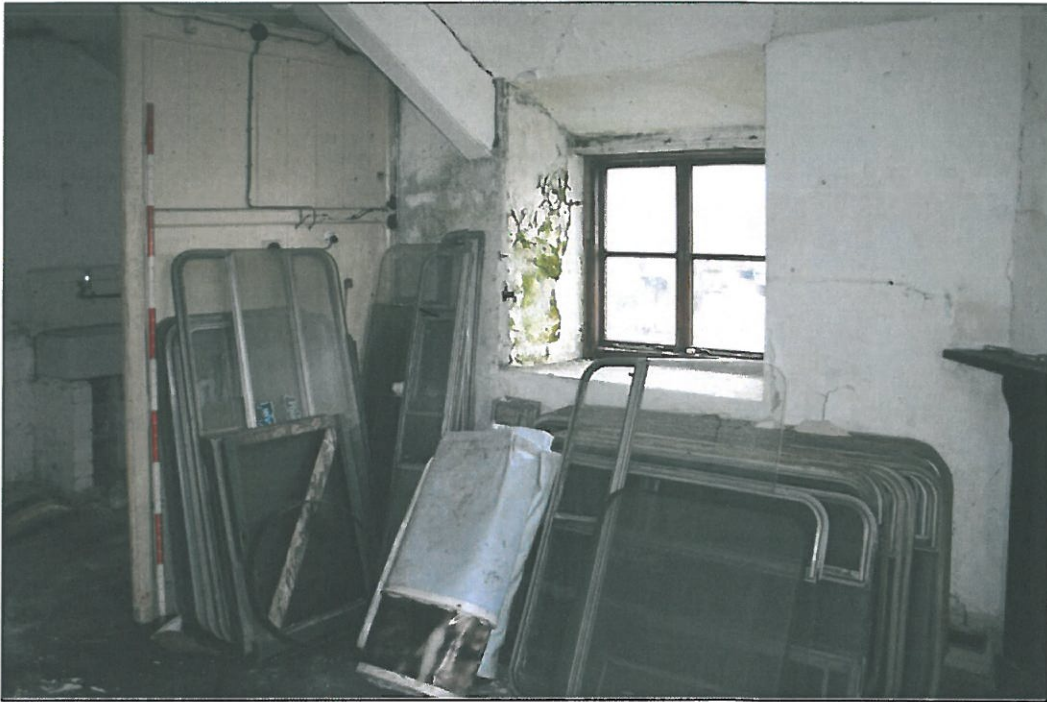
Figure 17: Office, looking south

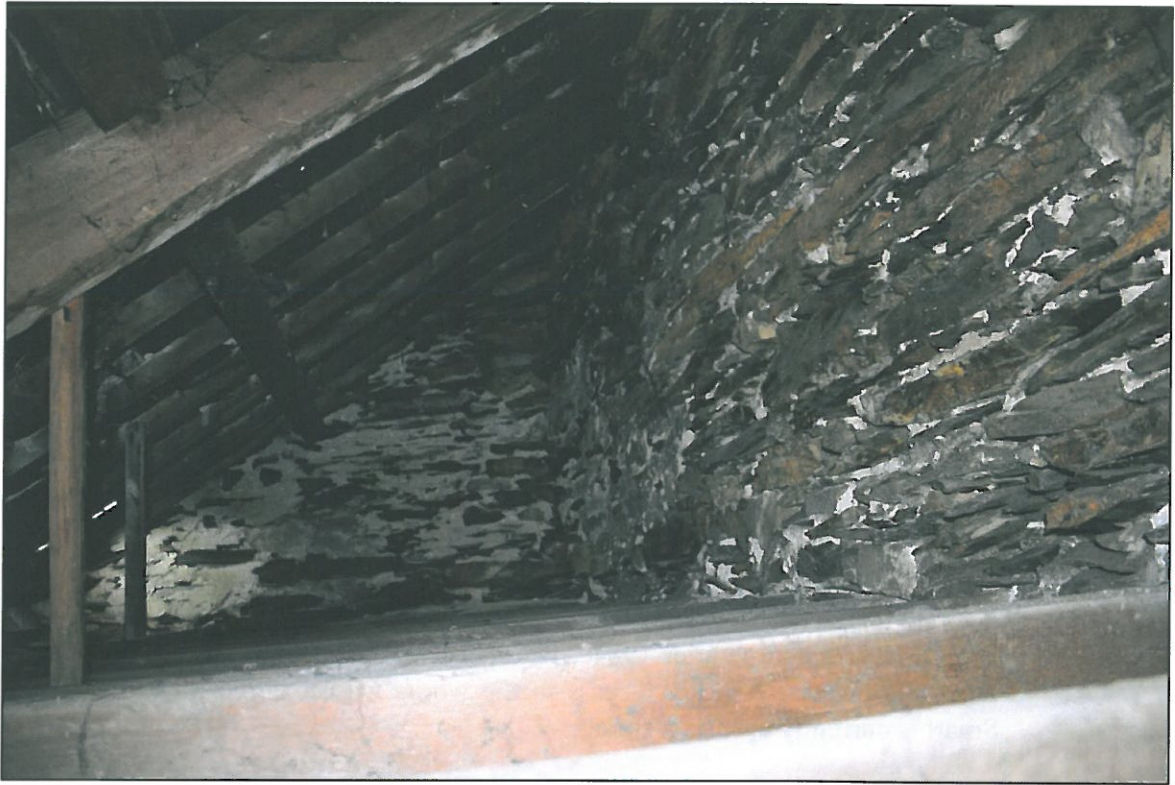
Figure 19: Roof space, looking north-west

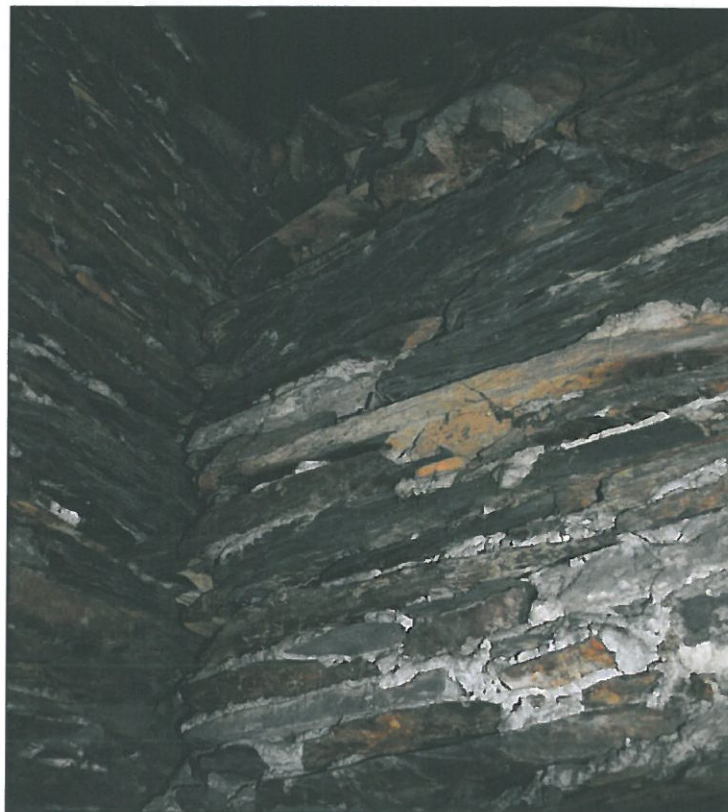
The pent slate roof of Plas Smart is carried on the gable end walls and a principal rafter, set into the front and rear walls, and visible within the office area. A purlin runs between the gable walls, is mortised into the principal rafter, and supports intermediate rafters at c.0.5m (1'8") centres. The slates are nailed to battens across the rafters (Fig. 19). The ceiling, carried on NE-SW joists, is partly supported by vertical battens nailed to the rafters. The butt joint between the south-east and rear walls (Fig. 20) has been mentioned above.

Figure 20: Roof space, butt joint in east corner
